NASA/TM-2009-215567
NESC-RP-05-125/05-045-E

STS-114 Engine Cut-off Sensor Anomaly Technical Consultation Report

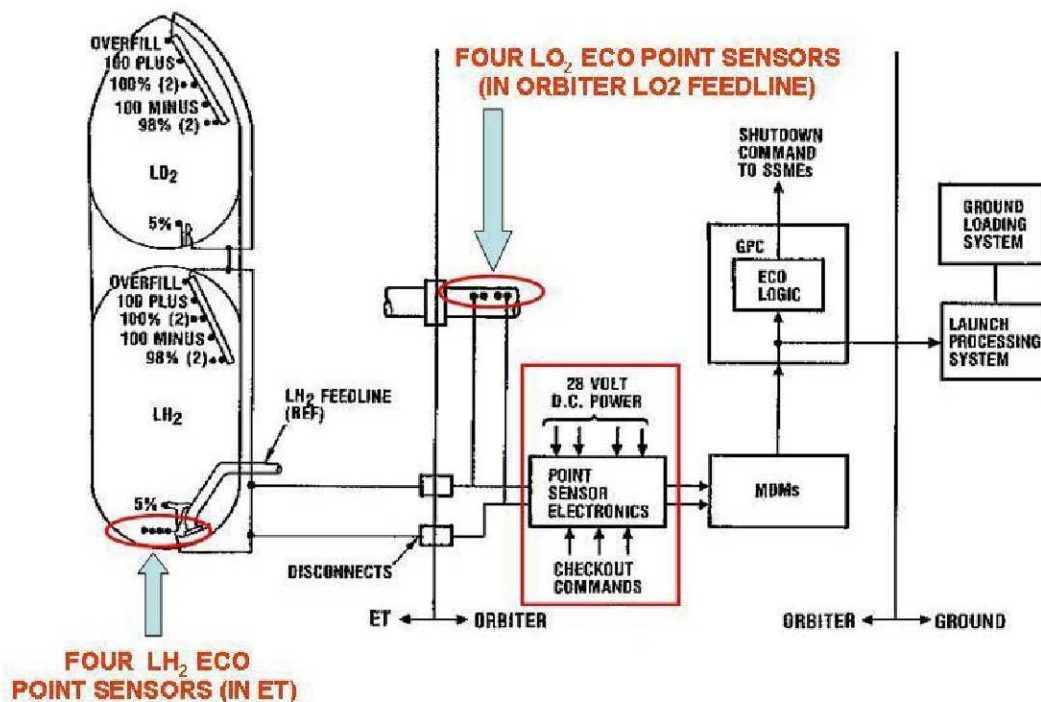
The MPS ECO system consists of point-sensors installed in the ET liquid hydrogen (LH₂) tank and the Orbiter's liquid oxygen (LO₂) feedline. Point sensor electronics are designed to condition signals and to provide appropriate stimulation of the sensors and associated wiring and connectors. Refer to Figure 6.0-1 for an overall schematic.

Figure 6.0-1. ECO and Liquid Level Sensors Block Diagram

The point sensor electronics interprets a low resistance at a sensor as the presence of cryogenic liquid, which provides a “wet” indication to the Multiplexer/De-Multiplexer (MDM) for use by on-board General Purpose Computers (GPCs) and the ground Launch Processing System (LPS). Conversely, a high resistance is interpreted as a “dry” indication. The point sensor electronics include circuitry suitable for pre-flight verification of circuit function and are designed to fail “wet”. For example, an open circuit in the sensor, or an open or short in the signal path, will provide a “wet” indication to the MDM. The system is then activated and checked out during launch countdown and remains active during ascent.

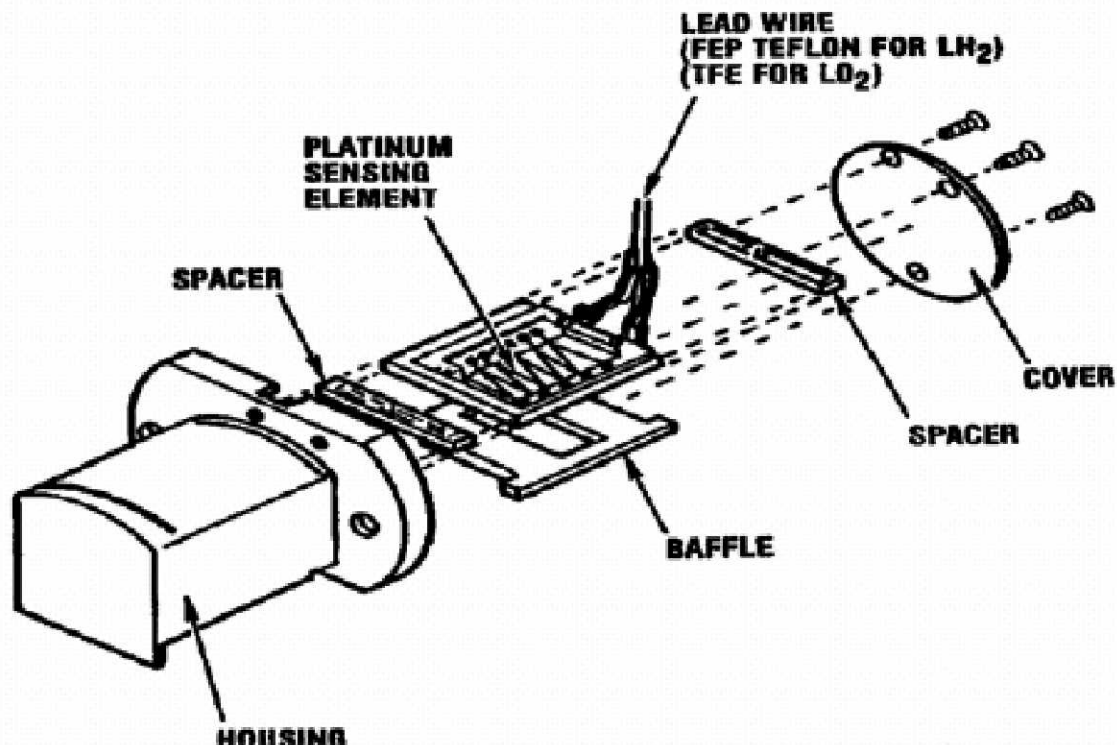
An ECO sensor is depicted in Figure 6.0-2. The sensor consists of a platinum wire sensing element mounted on an alumina Printed Wiring Board (PWB) and is encased in an aluminum

housing. The sensing element acts as a variable resistance which changes on exposure to cryogenic liquid. This resistance variation is detected by post-sensor (signal conditioning) electronics and is used to generate either a “wet” or “dry” indication as noted above.

Figure 6.0-2. ECO Sensor System Overview
